William A. Bugge Bridge

(Hood Canal Bridge - 104/5.2)

Replacement Plan

East-Half Floating Portion

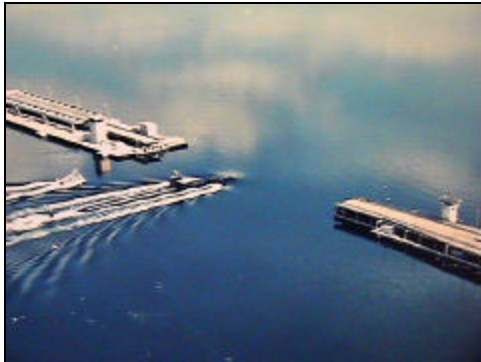
Reliable operation of the Drawspan is essential to vehicular and marine traffic, and timely openings for Trident submarines.

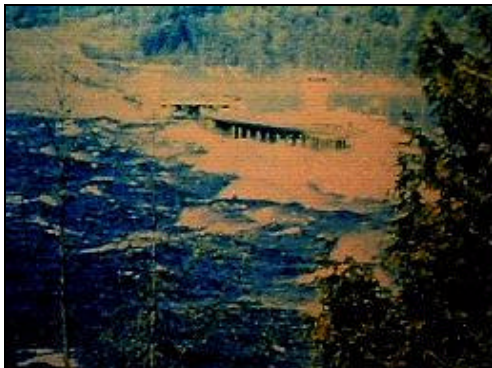
The probability and risk of damage from major storms is relatively high. The primary concern regarding the bridge's remaining service life is based on structural capacity and accumulative fatigue damage caused by major storms.

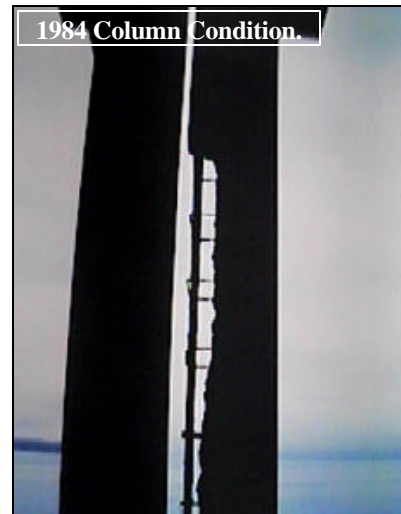
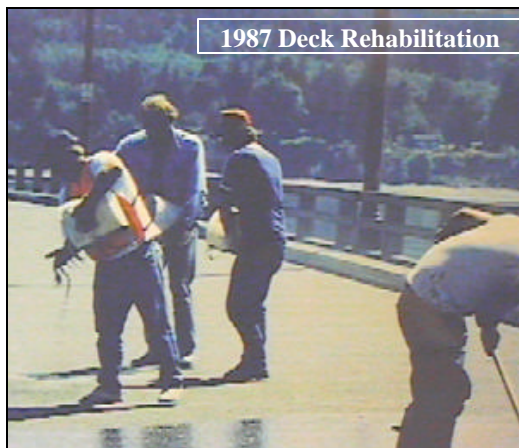
Spalled and deteriorated reinforced concrete columns were repaired during the 1984 rehabilitation. The Region reported the repairs included replacement of deteriorated concrete and heavily corroded reinforcing steel (Including column ties and main reinforcing steel bars).

In a 1987 contract, similar repairs to spalled and delaminated areas of the east-half and both approach roadway decks were required where as much as 50 percent section loss in deck reinforcing steel was encountered.

These areas of previous concrete restoration have aged and now are showing signs of deterioration and failure. Other concrete areas which did not require rehabilitation in the 1980's, now require work.

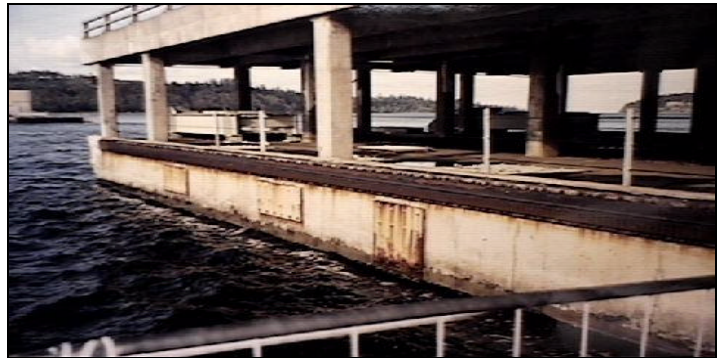
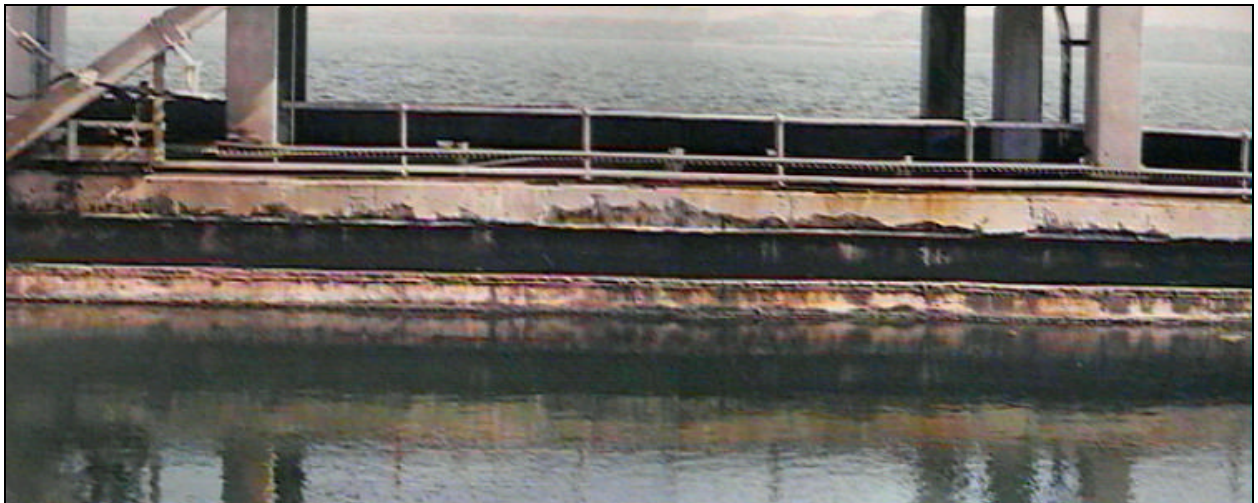
The opening problem is the result of high loads on the vertical guide-rollers causing excessive wear on the roller tracks, rollers, and equalizer frames. Misalignments caused by changes in pontoon configuration due to long-term creep, shrinkage, and unbalanced loadings are also contributing to the problem.

The current strategy is to continue to systematically eliminate binding points until the maximum 300 foot east-half opening is achieved. A long-term fix would require removal of the draw pontoon and replacement of all major mechanical components at an estimated cost of \$15-20 million and would involve two or more weeks of closure to vehicular traffic.
